Hurricane Barriers in New England and New Jersey — History and Status After Four Decades

Andrew Morang September 2007

Final report

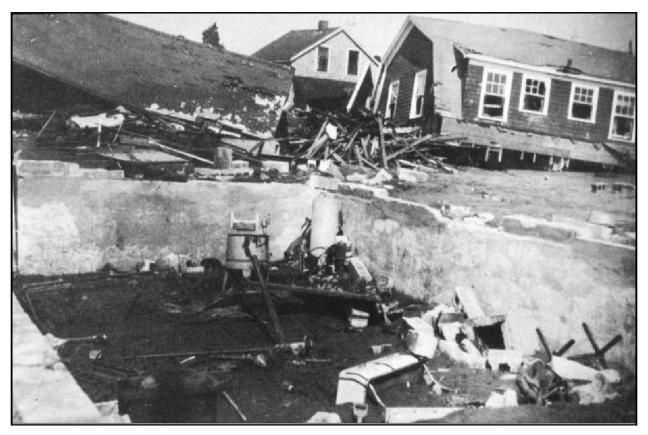
Figure 3. Island Park, near Portsmouth, RI, was overwashed by breaker (surge?) with reported height of 30 to 40 ft. From *The New England Hurricane*, Federal Writers' Project of WPA, 1938 (NOAA, http://www.photolib.noaa.gov/historic/nws/nwind31.htm, 15 November 2006).

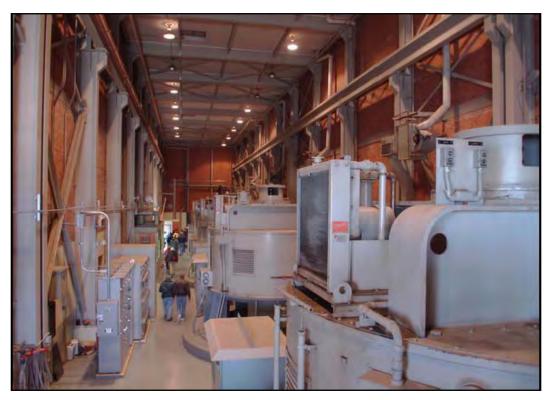
storm height of 25 ft NGVD. The five pumps were, at the time of installation, the largest of their type ever built (Figures 15 and 16). At a height of about 55 ft and diameter of 20 ft, they can transfer about 3.15 million gal/min from the Providence River into Narragansett Bay. The pumps receive electricity from the Narragansett Electric Company at 11,000 volts. There is no provision for on-site emergency generators.

Figure 15. Fox Point pump house, 4 November 2006.

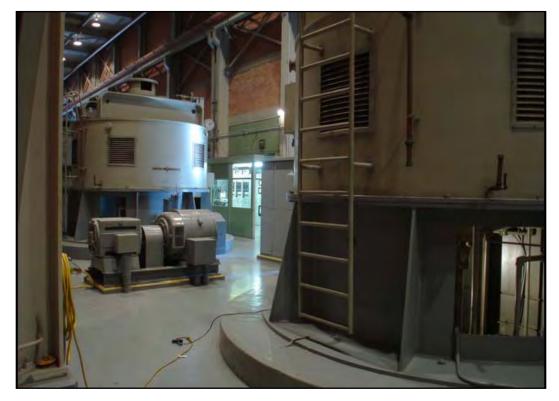
Figure 16. Pumps at Fox Point barrier, 4 November 2006.

During a site visit on 4 November 2006, City of Providence engineers reported that the plant and equipment were in good mechanical condition, and the pumps were recently overhauled. The electrical controls are original and need to be upgraded. The controls use electromechanical relays, and parts are increasingly difficult to replace (Figure 17). They reported that if electricity were interrupted in an emergency, the tide gates could be lowered by hand by manually releasing brakes. However, it would be impossible to raise the gates without electricity for the motors, and, of course, the pumps would not function to push Providence River water out to Narragansett Bay.

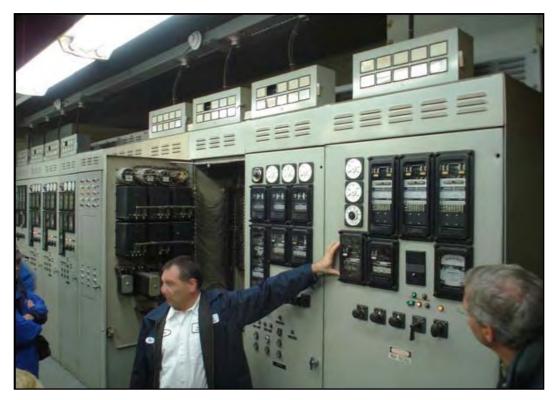
Figure 17. Controls for pumps and equipment, Fox Point pump house, 4 November 2006. Engineers are City of Providence employees.

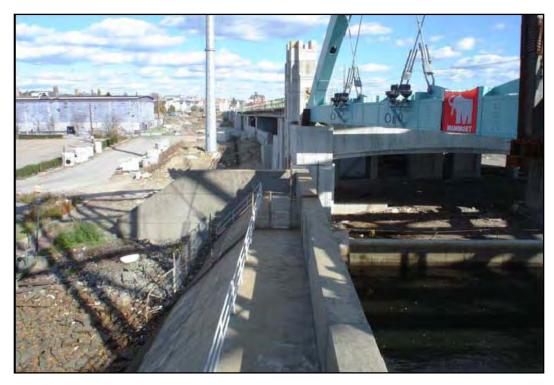
The new I-195 bridge has just been erected immediately south of the hurricane barrier. Part of the dike east of the river has been incorporated into the freeway ramps (Figure 18). The bridge had to be situated close to the barrier because of sewers and other conduits that cross under the Providence River further south. As a result, the pile foundation had to be carefully designed to avoid interfering with the H-piles of the hurricane barrier.

Figure 18. View east from Fox Point hurricane barrier showing ramps and newly-built I-195 bridge, 4 November 2006. Concrete freeway ramps substitute for some of original dike.

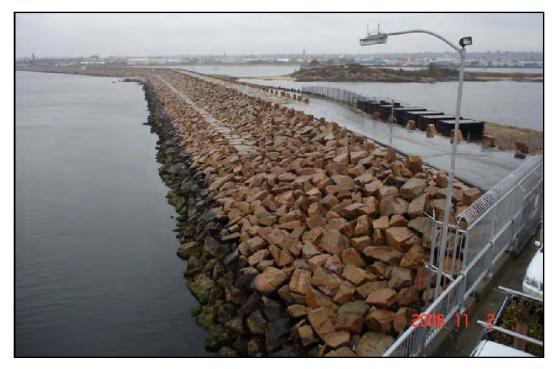
The rock-faced dike and concrete gate structure were built on a foundation of rock ledge. The site was isolated with coffer dams, dewatered, and excavated to rock basement (Figures 23-27). Stone for the dike came from Dartmouth, MA, a distance of only 3 or 4 miles. The stone workmanship is among the finest that this author has ever seen in a coastal structure outside of Italy. The core of the dike is impermeable, and the crest is wide enough for a crane to use as a roadway (Figure 28). The dike has not needed maintenance since construction.

Figure 28. View looking west along New Bedford hurricane dike from gate house, 2 November 2006.

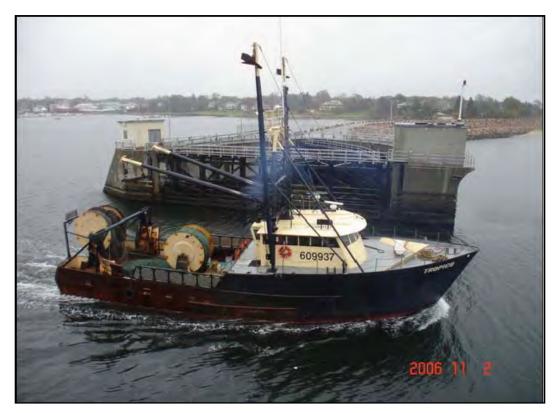
The main deep-draft channel to New Bedford has an authorized depth of 30 ft. Most traffic now consists of fishing boats and barges, but some cruise ships and larger ocean-going freighters use the channel (Figure 29). If larger vessels will need to enter the harbor in the future, the entire gate complex will have to be rebuilt. This will be very difficult now because when the original gate was under construction within its cofferdam, the navigation channel was temporarily rerouted to the east. Now the stone dike blocks this part of the harbor, and there is no other opening through which the navigation channel could be temporarily rerouted.

Figure 29. Fishing boat passing through 150-ft-wide Federal navigation channel in New Bedford hurricane barrier. View from gate control house looking east, 2 November 2006.

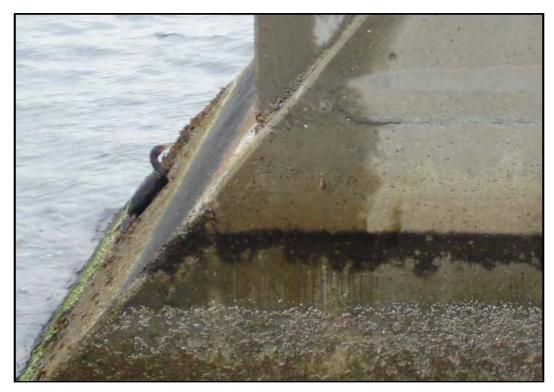
During the site visit on 2 November 2006, this author saw many cormorants (*Phalacrocorax auritus*) swimming in the channel and harbor and resting on the concrete walls (Figure 34). Other seabirds were also diving for fish.

Figure 34. Double-crested Cormorant resting on gate abutment, 2 November 2006.

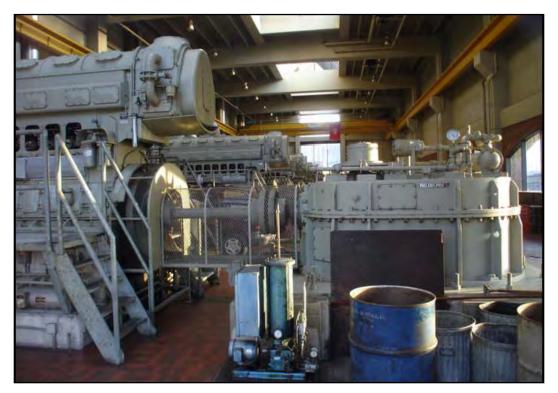
Figure 52. Diesel engines and pumps in Charles River Dam, 1 November 2006.

Property in the Charles River Basin is highly sensitive to changes in water level and the elevation must be kept between 107.0 ft and 109.9 ft (MDC datum). At 107 ft, boating problems occur, while at 109.7 ft, low areas along the shore begin to flood. At spring tide, Boston harbor water is higher than the Charles River level. The Charles River Dam is also unusual in that high runoff into the basin cannot be controlled by the six pumps alone. The gates on the sluices must be manipulated in addition to using the pumps, and the water in the basin must be lowered before a major storm in anticipation of the inflow of runoff and rainfall. The pumps are in good condition and the impellers have not displayed signs of brittleness. 1
